CASABO FAMILY FILMS:

An Account of the Film Preservation Process

Preservation Project Background

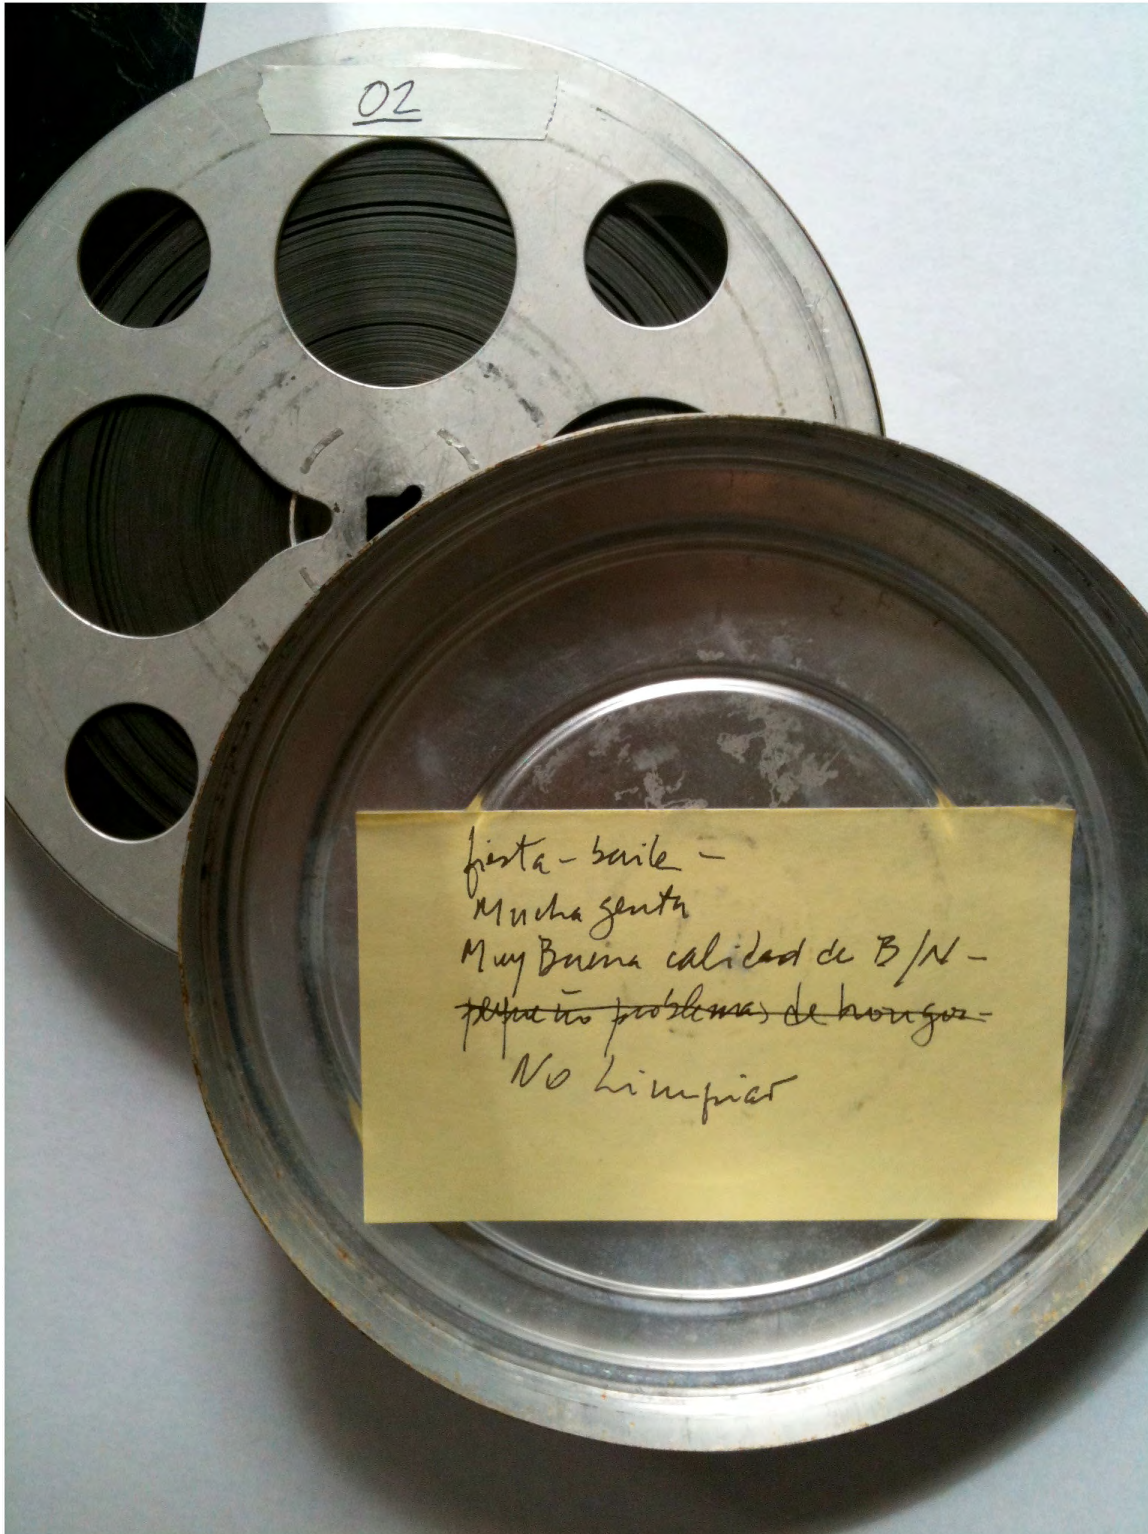
festa - baile -
Mucha gente
Muy Buena calidad de B/W -
~~pero no problemas de hongos -~~
No limpiar

Inside the original Ektachrome metal can, is a handwritten paper note that reads:

“Fiesta-Baile- mucha genta - Muy Buena calidad de B/W – no limpiar”

“Party-Dance- many people – very good quality black and white – do not clean”

“small problem with mold”
